DEPARTMENT OF TRANSPORTATION

Quality Assurance and Source Inspection

Contract #: 04-0120F4Cty: SF/ALA Rte: 80 PM: 13.2/13.9File #: 19.28**WELDING INSPECTION REPORT****Resident Engineer:**Pursell, Gary**Address:** 333 Burma Road**City:** Oakland, CA 94607**Report No:** WIR-012169**Date Inspected:** 18-Feb-2010**Project Name:** SAS Superstructure**OSM Arrival Time:** 1500**Prime Contractor:** American Bridge/Fluor Enterprises, a JV**OSM Departure Time:** 2330**Contractor:** American Bridge/Fluor Enterprises, a JV**Location:** Job Site**CWI Name:** T. Pasqualone & J. Cayabyab**CWI Present:** Yes No**Inspected CWI report:** Yes No N/A**Rod Oven in Use:** Yes No N/A**Electrode to specification:** Yes No N/A**Weld Procedures Followed:** Yes No N/A**Qualified Welders:** Yes No N/A**Verified Joint Fit-up:** Yes No N/A**Approved Drawings:** Yes No N/A**Approved WPS:** Yes No N/A**Delayed / Cancelled:** Yes No N/A**Component:** N/A**Bridge No:** 34-0006**Summary of Items Observed:**

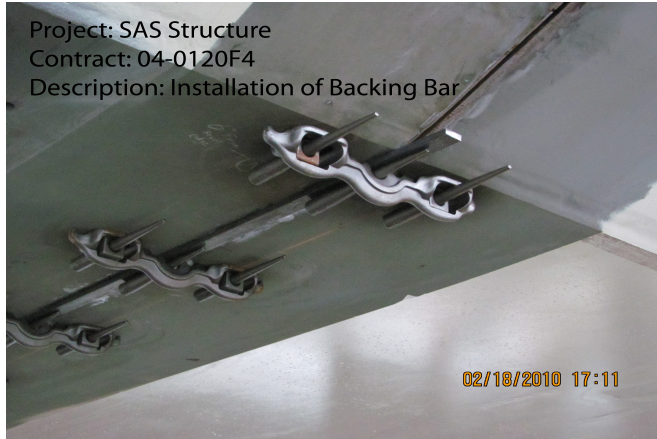
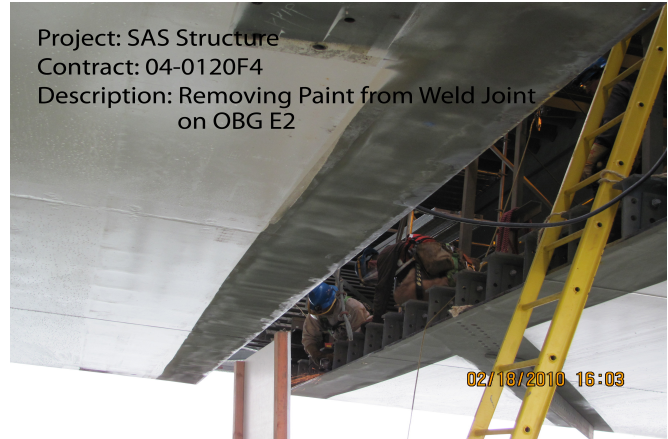
The QAI observed the installation of the backing bar at the E1 to E2 field splice utilizing unique fitting aids to bring the backing bar in contact with the bottom plates. The backing bar appears to comply with the contract documents.

Later in the shift the QAI also observed the AB/F personnel removing the zinc primer from the weld joint preparation of the Orthotropic Box Girders (OBG) identified as E2 and E3 prior to the final positioning of E3 OBG.
